Technical Extension for Rivercare in Tasmania - CASE STUDIES

CASE STUDY 1

The Dasher River.....

a case study of community success

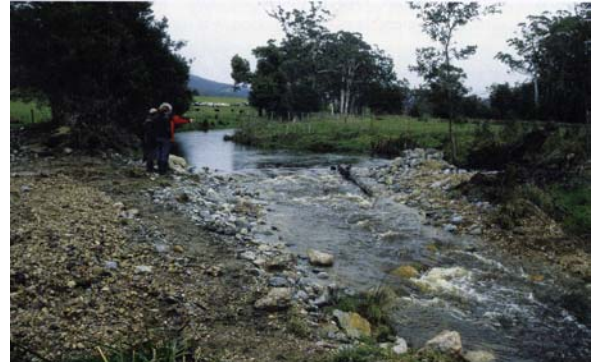
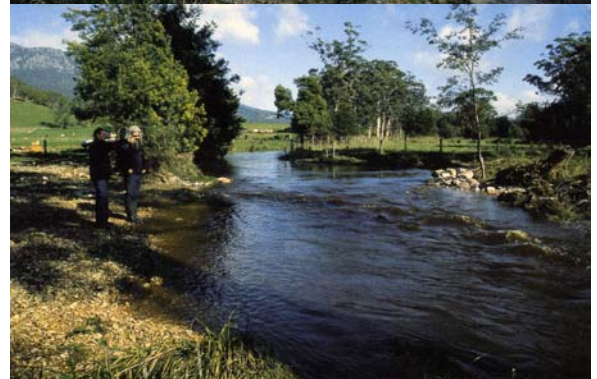
These two pictures show the difference in water quantity on the Dasher River, at low flow (top) and high flow (bottom).

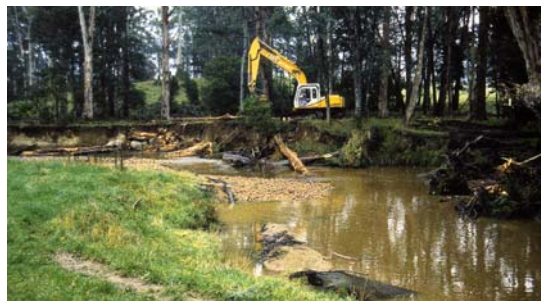
Adding woody debris to the Dasher River

erosion and sediment being deposited in the timber voids rather than being transported further downstream. The timber structures have also become favoured habitat for the native blackfish.

Structural works included rock riffles and the innovative use of timber structures within the river. These were put in place to reduce the throughput of sediment in the river, which was degrading healthier downstream areas that often contain significant conservation values. The structures were designed with input from the Rivercare geomorphologist and engineer. This ensured that important details such as fish passage, bank erosion and head-cutting were addressed. Since the in-stream structures have been put in place there have been a number of bank-full flow events. To date the structures are operating as expected, with reductions in bank
