Minnow Catchment Action Plan

Completed by Peter Stronach with the support of the Mount Roland Rivercare Inc.

Version: 25/07/2016

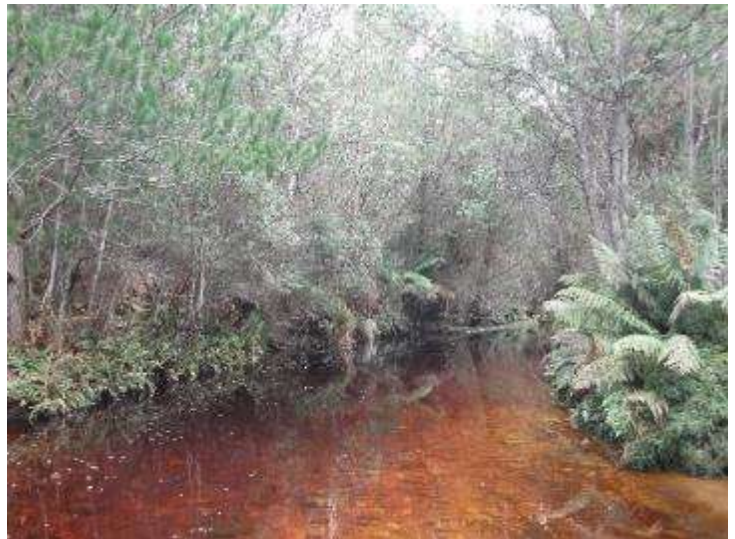
Photo 2 MR3.1 Radiata Pine in Riparian Zone (Barbara Alsop)

Reach Code	River style	Site Description	Conservation Values	Issues/Threats	Recommendations	Priority	Status
MR3.1	Meandering Gravel Bed, Partial Valley Confined	Highly degraded. This reach is dominated by the surrounding Radiata pine plantation. There are several patches of native vegetation remnants including forest and swamp areas along or near the main channel. (see Map 3 – red circles)	Conservation values are poor, but have the potential to greatly improve if reconnected to the greater Mt Rolland environment and existing native remnant riparian zones of MR 2 and MR 3.2	<ul style="list-style-type: none"> High levels of sedimentation caused by forest plantation harvesting & road infrastructure with little or no riparian protection – i.e. inadequate buffers. Weed spread e.g. wildings are infesting the riparian zone. 	Develop a comprehensive Restoration Plan (including MC4 on Minnow Creek), and all adjoining and/or nearby remnant native vegetation (e.g. the wetland and remnant to the north of Belstone Ford and the remnant forest upstream of the confluence with Minnow Creek) (see map). Natural regeneration is likely to occur if threats are removed (e.g. wildings controlled), however pine wilding control will be on-going and long-term.	Strategic	PTPZ

- MC1 and MA1: Retain existing high conservation value forest in these reaches.
- MR3.1 Rehabilitate riparian buffer (A comprehensive restoration plan should be developed for this reach including M3.2, MC4 on Minnow Creek and lower MA2 & MB1.)
- MR3.1 and MB1: Incorporate existing remnant vegetation into rehabilitation activities, including flood channels and wetlands.
- MC4 Reinststate riparian buffer for Minnow Creek

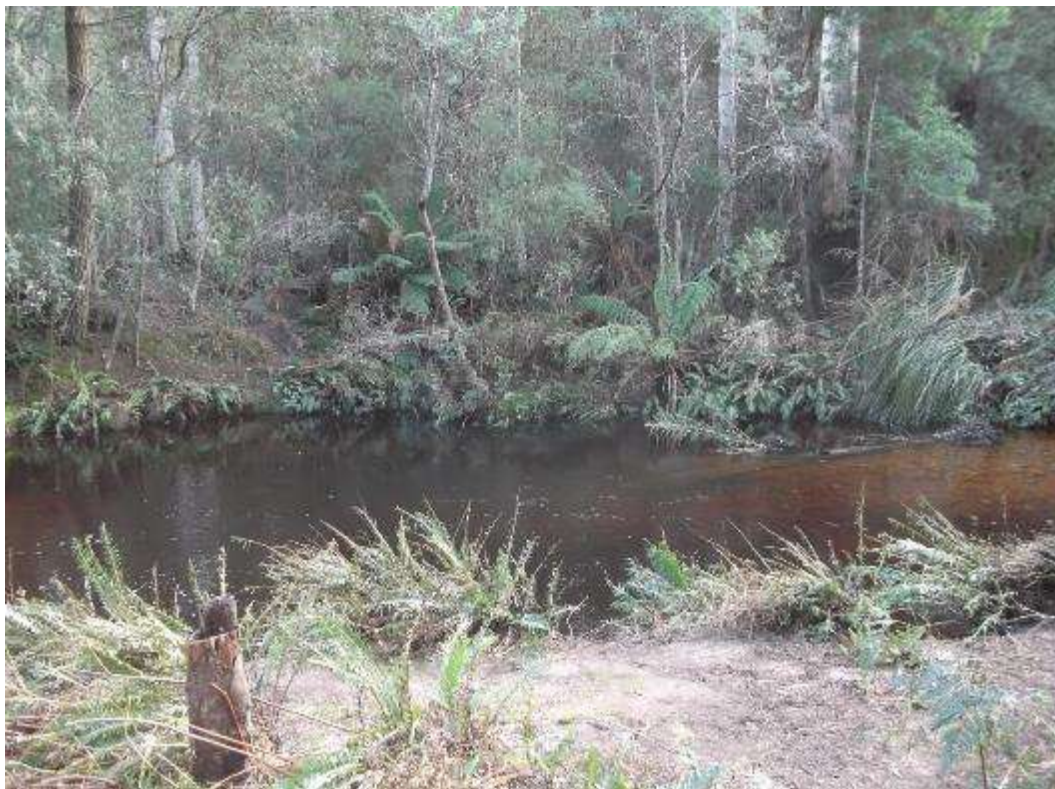
Photo 4 MR3.2 (Minnow River) near Picnic Area

Reach Code	River style	Site Description	Conservation Values	Issues/Threats	Recommendations	Priority	Status
MR3.2	Meandering Gravel Bed, Partial Valley Confined	Good native vegetation cover, surrounded by plantation. 400m of the northern bank is in pine plantation to the water (no buffer).	Riparian zone has native vegetation in fair/good condition. Linked to large area of high conservation value vegetation to the south (Kenzies Hill Reserve)	<ul style="list-style-type: none"> Impacted by harvesting activities and pine wildling invasion. Pine in riparian zone northern side of reach. 	Include northern side of riparian zone in comprehensive Restoration Plan for MR3.1 (see MR3.1 recommendations above). Ensure harvesting near riparian zone is done sensitively with restoration as the primary focus. Long-term follow up weed control will be required.	High	PTPZ
					Employ specialist - <i>Astacopsis gouldi</i> survey and collect data for inclusion in the NVA	Moderate

- M3.2 and MU1: Retain existing high conservation value forest in these reaches.
- MR3.2 - Include northern side of riparian zone in comprehensive restoration plan for MR3.1 (see MR3.1 recommendations and Table 2).
- MR3.2 and tribs All reaches.–NVA - Collect records using camera trapping and field observations (not only *threatened* species). Identify and collate TASVEG communities, boundary and reserve information etc. for future updating Collect additional data on threatened species for inclusion in the NVA.

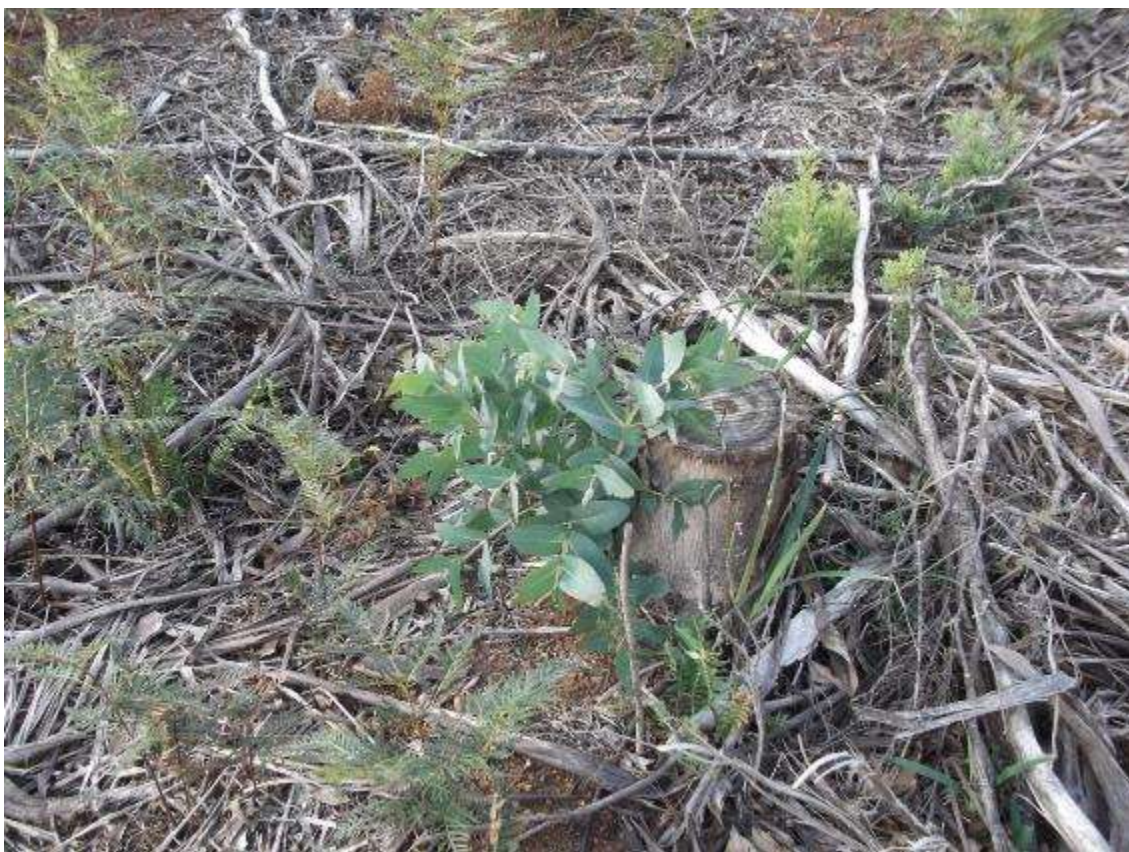
Photo 5 Proposed area for restoration of harvested *Euc. nitens* plantation north of Beulah road on MR 4. *Euc nitens* resprouting will need to be controlled. Native regeneration is exceptional at this site.

Reach Code	River style	Site Description and Condition	Conservation Values	Issues/Threats	Recommendations	Priority	Status
MR4	Partially Valley confined Occasional Floodplain	Forest area starts near Paradise Rd Bridge & picnic area (see MR3.2 and Kenzie Hill Reserve), continues for 1.2 kms with a continuous riparian zone with a minimum of 30 metre buffer. Plantation on the south of the river to Lower Beulah Rd (see Map 5). The plantation zone has a high recovery potential	High conservation value vegetation with a relatively intact (re plantation to the south), riparian zone, adjoining natural areas. Remnant corridors are on both sides of the river.	<ul style="list-style-type: none"> Blackberry from ME reaches and Euc nitens from adjoining coupe. Harvesting has noticeably affected on the condition of riparian zone through exposure and edge effect. 	Restore harvested Euc. nitens plantation zone north of Beulah road (see map). This will require a Recovery Plan and ongoing weed control (mainly Euc nitens regrowth from old stumps) (See Map 5).	Strategic	PR,PTP Z, PUR,

- MR4, ME2 and ME8: Retain existing high conservation value forest in these reaches.
- MR4 – Restore harvested plantation North of Beulah Rd to native vegetation Include northern side of riparian zone in comprehensive restoration plan for MR3.1) (See Map 5).
- ME2. NVA - Collect records using camera trapping and field observations (not only *threatened* species). Identify and collate TASVEG communities, boundary and reserve information etc. for future updating. Collect additional data on threatened species for inclusion in the NVA.
- ME 2, ME5 and ME8 - Establish riparian corridor but MUST include all activities relating to the rehabilitation of riparian corridor on plantation land, fencing on agricultural land and landholder commitment of follow up weed control.

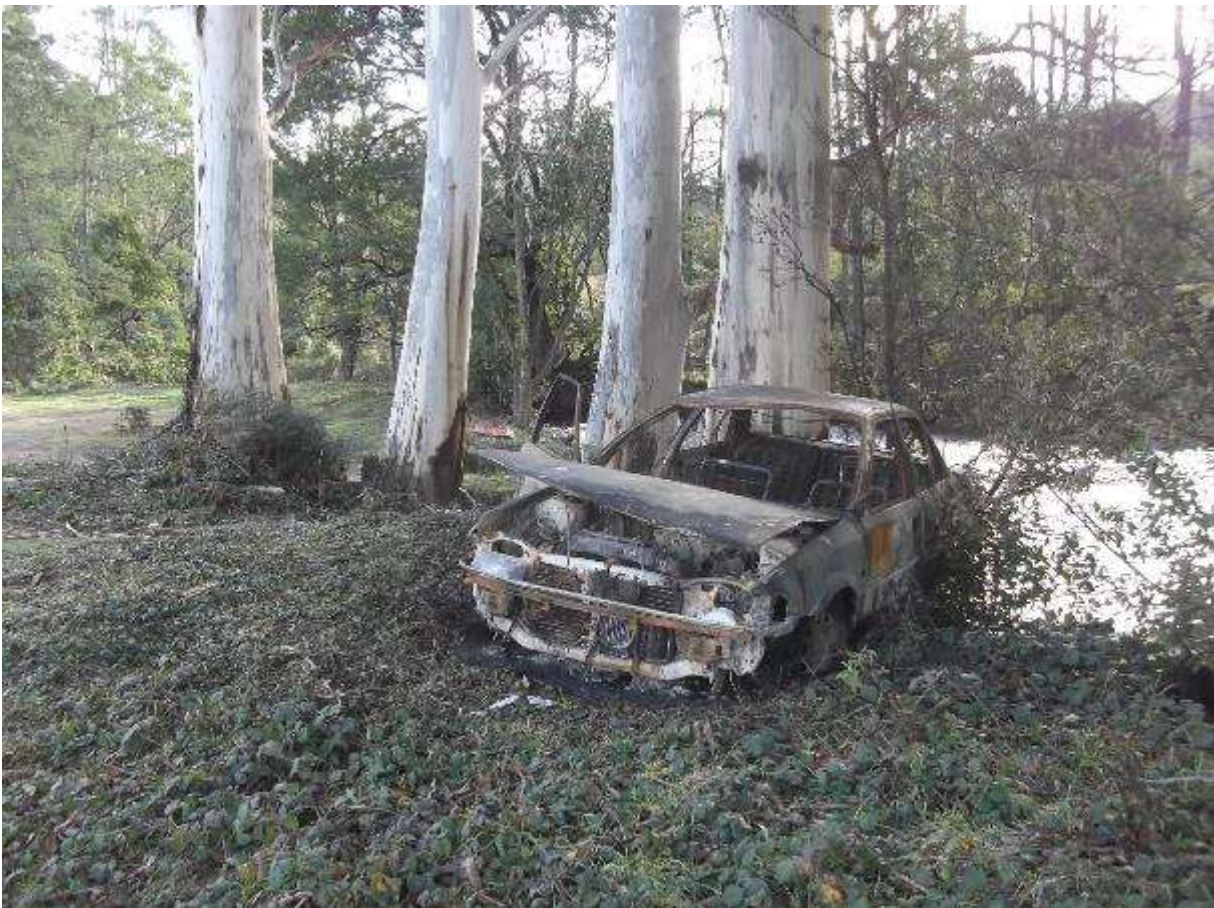
Photo 6 Example of vandalism and weeds while still retaining mature trees in MR5.1 riparian zone

Reach Code	River style	Site Description	Conservation Values	Issues/Threats	Actions	Priority	Status
MR5.1	Meandering Gravel Bed	This reach is highly degraded. Starting at the confluence with MNB2, it is distinguished by a large meander bend. The floodplain is highly disturbed by off-road vehicular traffic/vandalism. Vehicles are accessing via a number of openings through the riparian vegetation and/or across the river. Bank and floodplain erosion is evident.	<ul style="list-style-type: none"> Although degraded, there are some important mature trees Adjoins MNB2 and the upstream reach MR4 – which are both in good condition. 	<ul style="list-style-type: none"> High level of disturbance. Bank and floodplain erosion. Abandoned vehicles, vehicular damage and waste. Extensive blackberry present. Montpellier broom present 	Restrict car access using bollards/rocks at strategic access points including access through plantations	Strategic	PUB, Private, PR

- MR5.1 - Restrict car access using bollards/rocks at strategic access points including access through plantations

Allow for natural regeneration - close proximity of good native seed source	High	
					Blackberry containment and Montpellier broom control essential	High	
					Monitor weed incursion which may accelerate as threats are reduced	High	
MR5.2	Meandering Gravel Bed	Downstream from MR5.1 this reach retains some riparian vegetation in fair condition although the understorey is largely impacted by weeds (mainly Blackberry). There is a small native remnant attached to this area.	Canopy structure present within the riparian zone (surrounded by extensively cleared land). Some value in the understorey in some areas. The small remnant is a threatened community : Eucalyptus amygdalina forest and woodland on sandstone (DAS) (See Map 6)	<ul style="list-style-type: none"> Blackberry and Montpellier broom Mature pines and wildlings. Agricultural weeds invading via MNB1 	East of bridge selective control of mature pine required (below Beulah Rd bridge)	Low	PUB, Private, PR

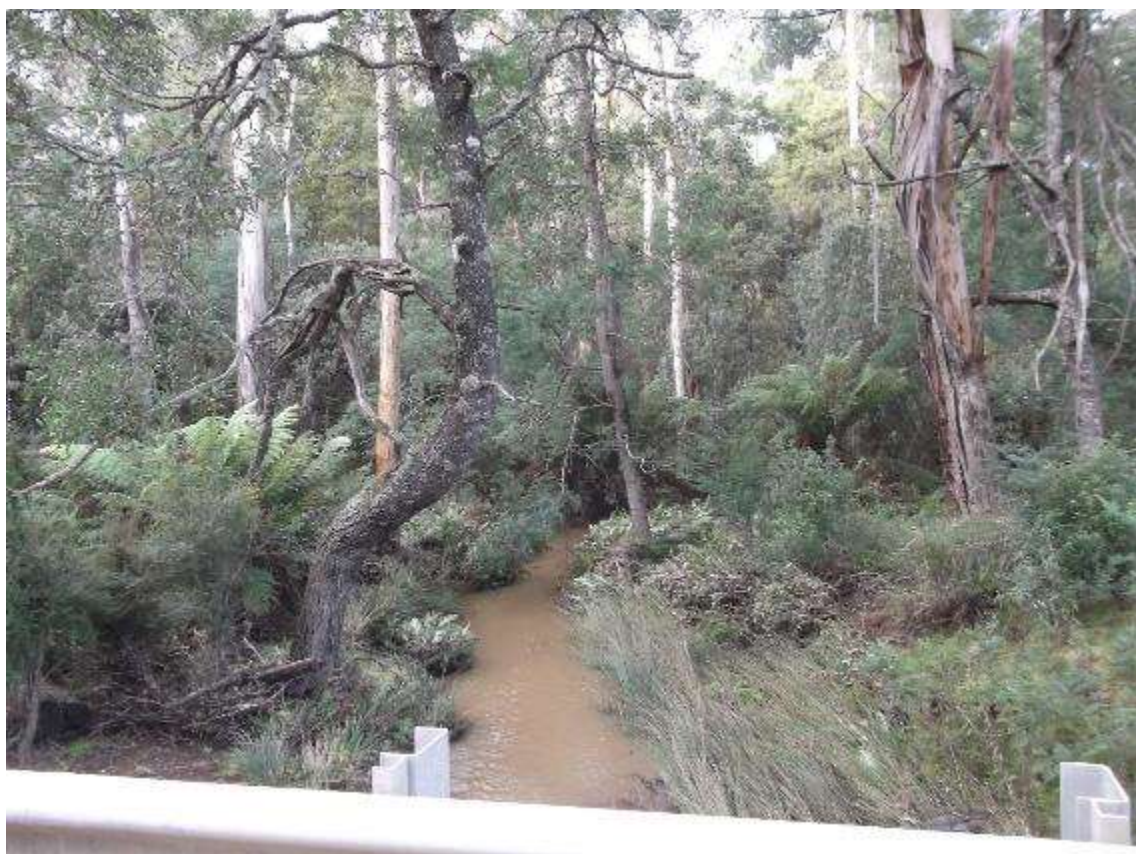
Photo 8 From Back Beulah Rd looking downstream to MNP2 NB: poor water quality from upstream impacts in MNP1

Restrict vehicle access to the riparian zone (access via Lower Beulah Rd).	High	
					Identify unclassified vegetation community and formalise with TASVEG (State govt) (see Map 10).	Strategic	
					Protect native vegetation.	High	
					Monitor and control willow and Spanish Heath. Develop and implement a weed management plan for the Minnow Catchment (see Priority recommendations for MR8 and MND (Includes Back Beulah R/See Map 10)).	High	
MNP1	Undefined tributary	Agricultural and plantation land. This tributary is highly degraded with little native vegetation present until reaching the Lower Beulah Rd Bridge (MNP2).	Low conservation value.	<ul style="list-style-type: none"> Spanish heath Unrestricted stock access Willows Poor riparian zone 	Develop and implement a weed plan for the Minnow Catchment (see Priority recommendations for MR9 and MNP (Including Back Beulah Rd).	Strategic	Private, PUB, PTPZ

Restrict stock access in lower MNP1.	Low	
MNP2	Undefined tributary	This reach begins at the Lower Beulah Bridge Rd entering a stretch of mature native vegetation. A confined channel continues into the lower section of MR9.	Nearly intact native riparian vegetation. Adjoining remnant vegetation is in good condition although impacted by selective native forest logging on Conglomerate Hill	<ul style="list-style-type: none"> Upstream weed spread 	Monitor and control willows, Spanish heath and Elisha’s tears. Retain native vegetation and allow for natural regeneration.	Moderate	Private, PUB, PTPZ
