## **Mount Roland** **LAND CARE**

**So why did the Giant Freshwater Crayfish cross the road?**

**New findings from a Mount Roland Land Care study**

**July 2025**

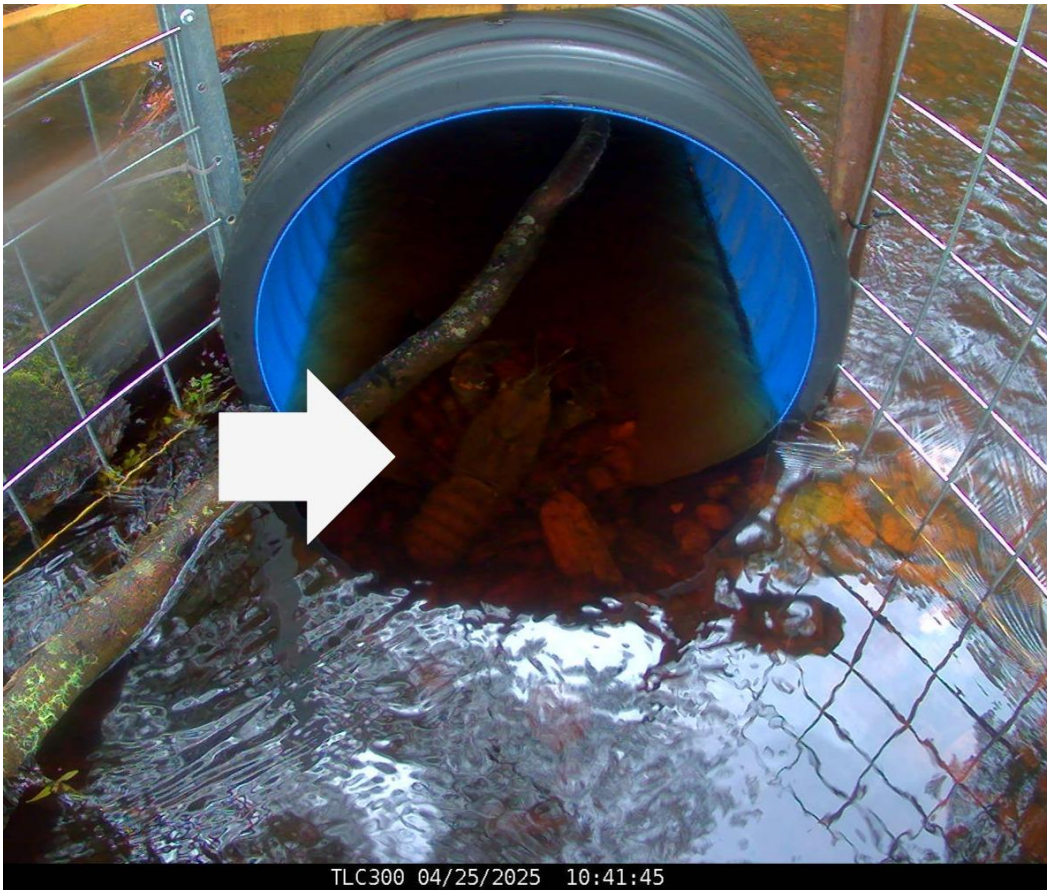
**Picture 1. GFC Entering a Culvert Heading Downstream:**

A number of GFC were observed to move in a *downstream* direction through the culvert [Pictures 1 and 2]. Traverse of the culvert was observed to take between a few seconds and up to 13 mins. The GFC appeared to move easily and quickly into the culvert, occasionally lingering inside the culvert near its middle.

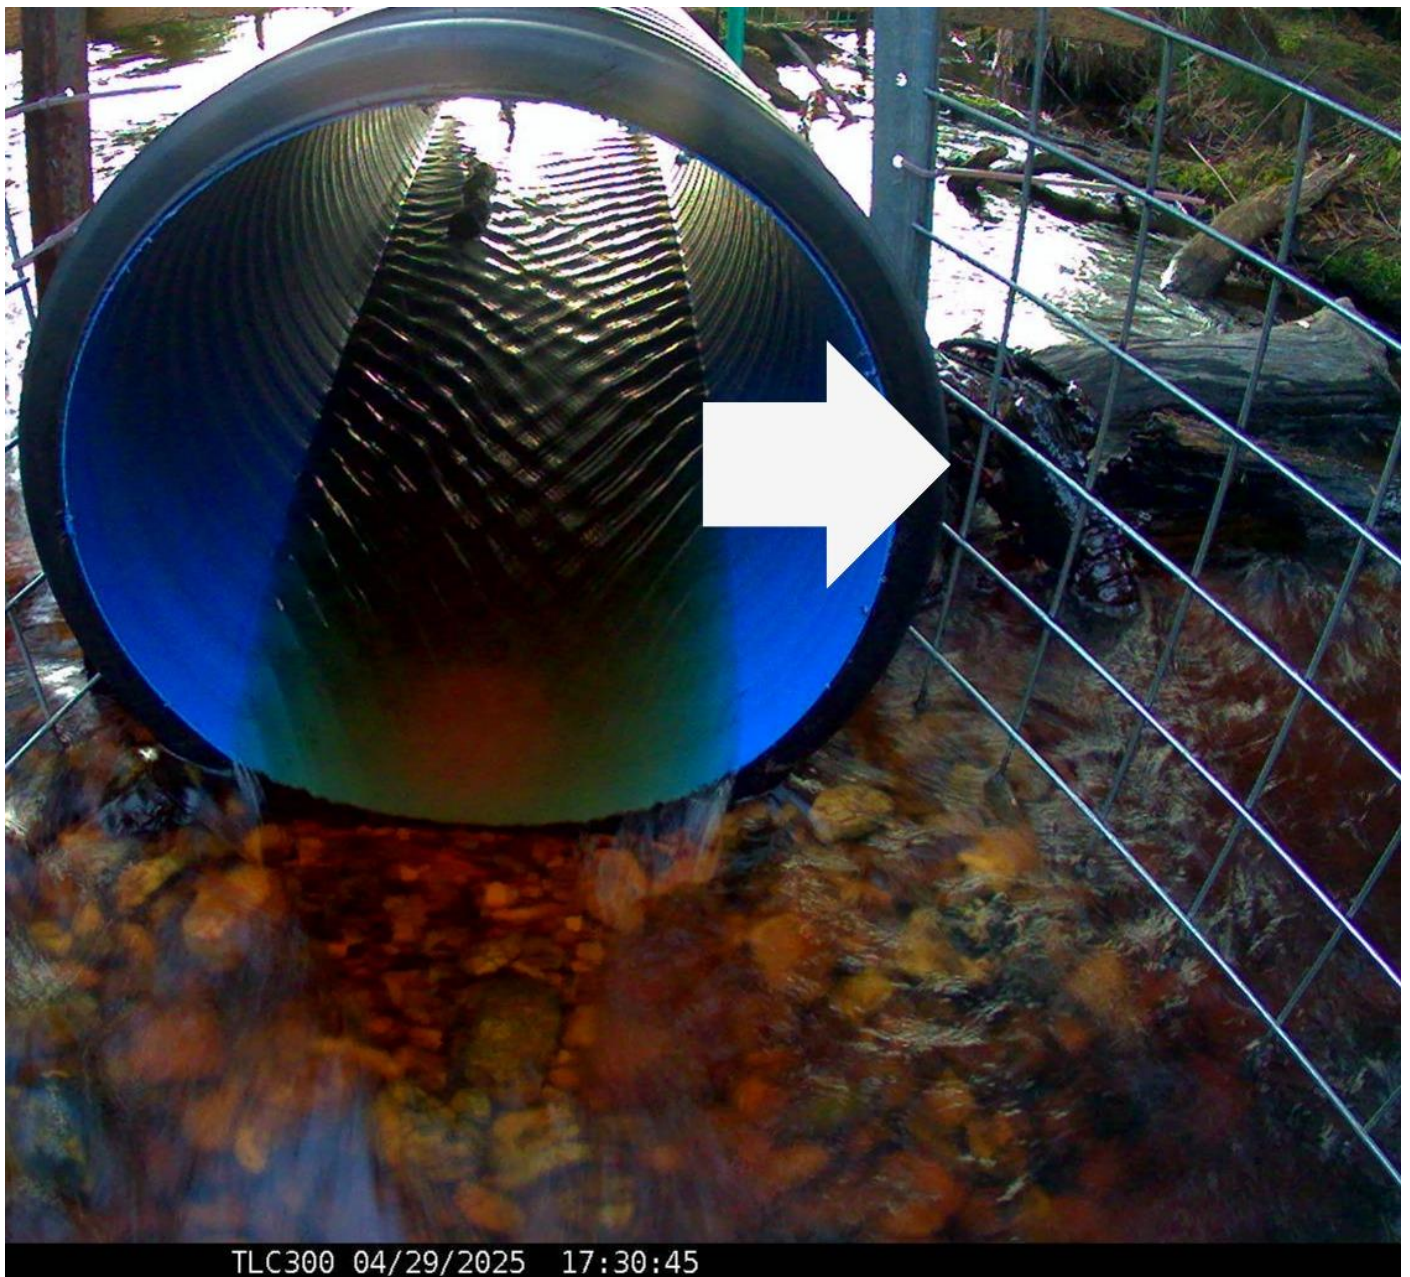
Picture 3. GFC Bypassing Culvert When Heading Upstream:

We have no observations that GFC were moving, or even attempting to move, of their own volition *upstream* through the culvert. There is footage, however, of GFC moving upstream outside the culvert and the fences, close to the river edge [Picture 3].

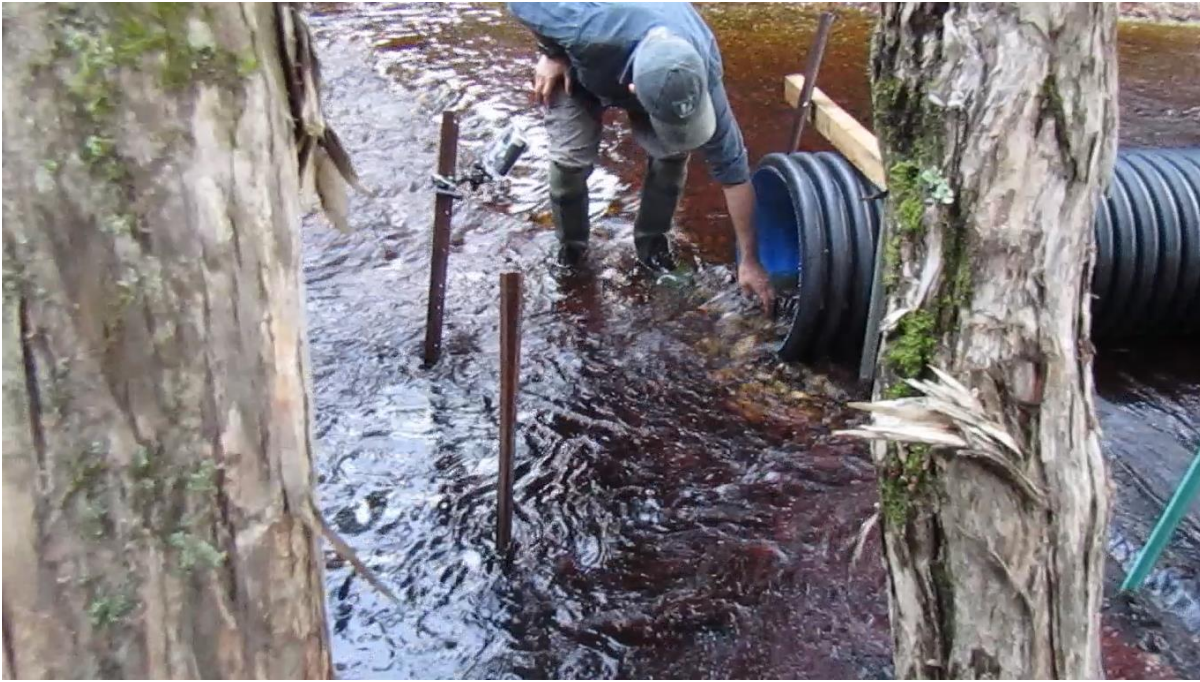
**Picture 4. Placed GFC Successfully Moving Upstream Inside a Culvert on Stone Base:**

When our expert, Todd Walsh, physically placed a GFC in the downstream end of the culvert, the GFC moved in an upstream direction through the culvert when the stone substrate base was present. This exercise was repeated later in the study when the stone substrate had been washed away. In this case the GFC was unable to gain purchase on the slippery bottom of the culvert: despite attempting to gain access he was repeatedly washed back out. Both of these episodes were captured by our cameras [Pictures 4 and 5].

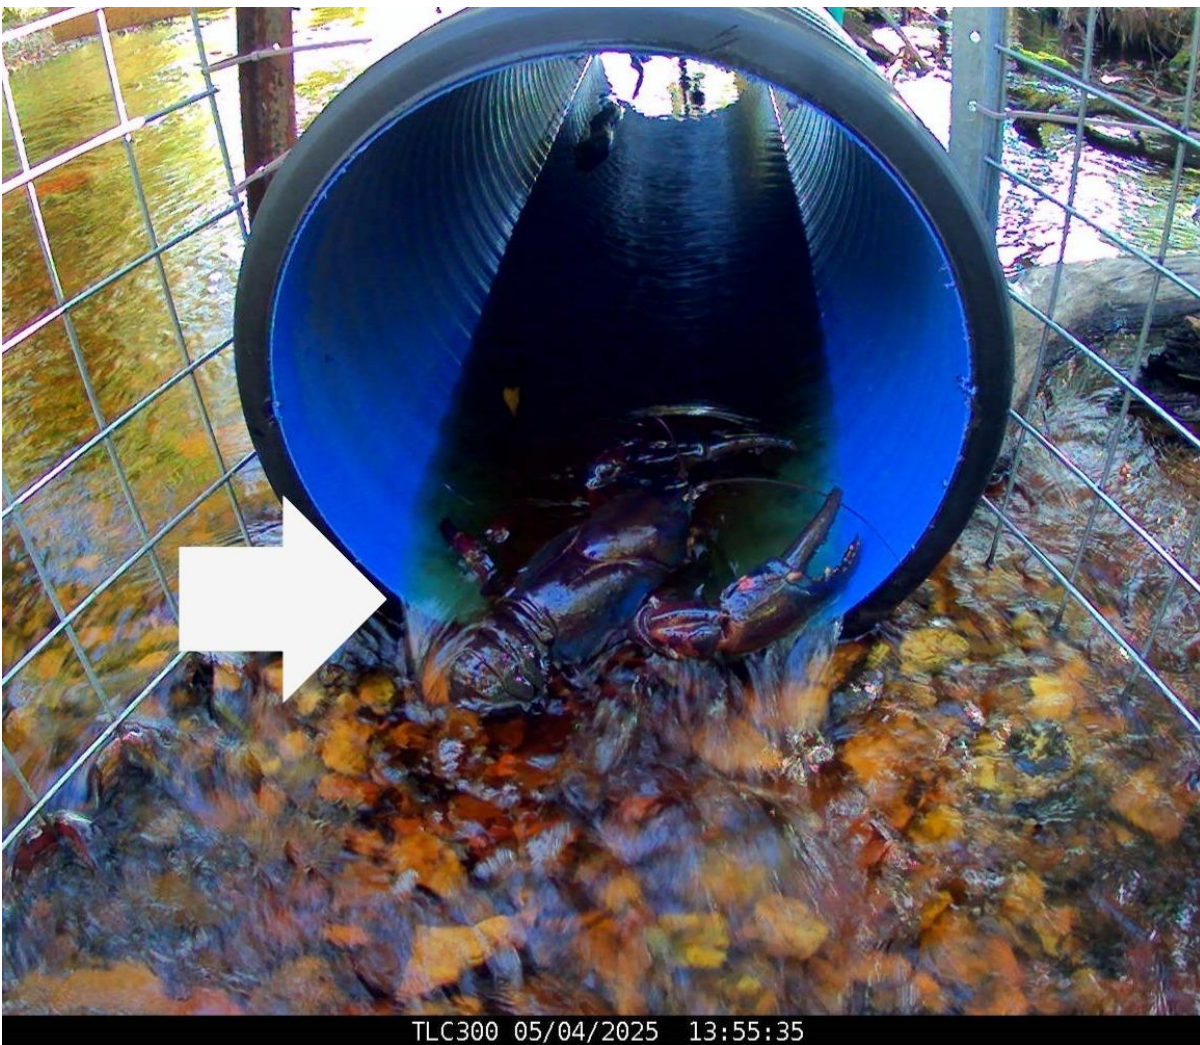
**Picture 5. Placed GFC Unable to Gain Traction on Bare Culvert Base when Heading Upstream:**
