Helping Tasmania's freshwater wildlife move safely

Mount Roland Land Care trials practical solutions to improve “water highways” for endangered Giant Freshwater Crayfish and other aquatic species

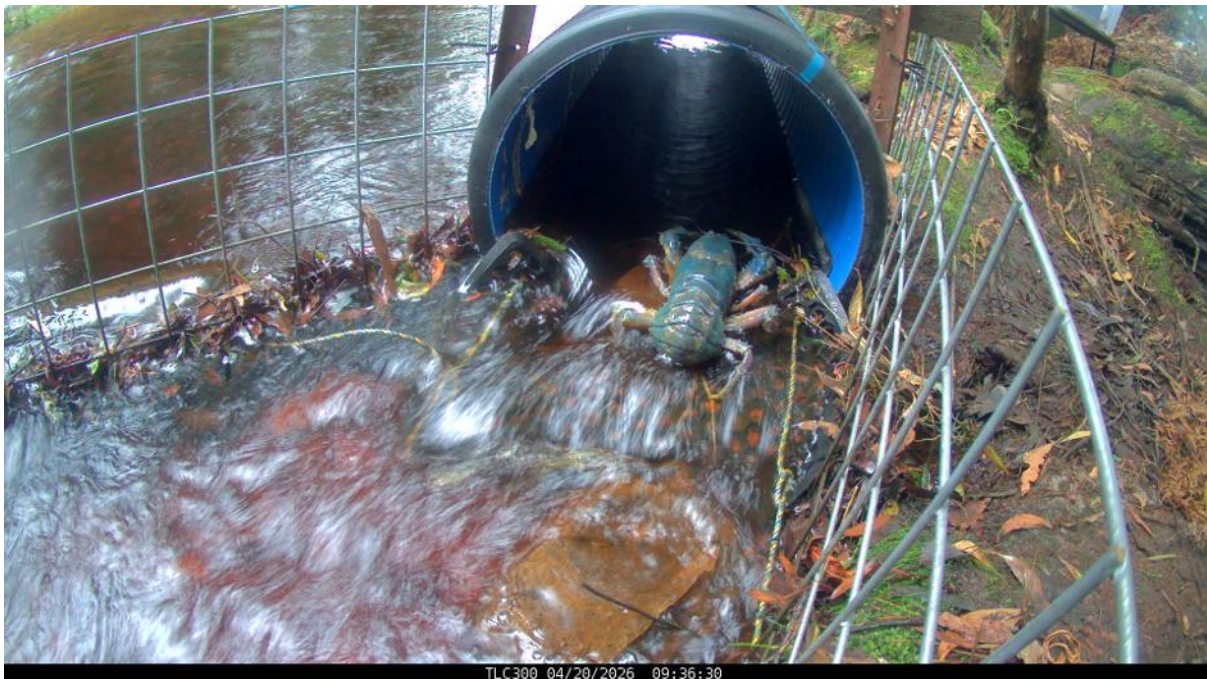
GFC moving upstream over rubber mats. Picture credit: Mount Roland Land Care

Researchers trialled simple rock ramps beneath culverts to improve access and installed roughened surfaces inside culvert pipes to restore traction.

The modifications used readily available and relatively inexpensive materials including local rocks and linked rubber floor mats.
